<p><b>CLIENT</b></p>	<p><b>PROJECT</b></p> <p>Whitehill Quarry, Burford Proposed extension</p> <p><b>TITLE</b></p> <p>Development Stage A - End Working Phase 2</p> <p><b>SCALE</b> I: 1250 @ A0 I: 2500 @ A2</p> <p><b>DRAWN BY</b> KH</p> <p><b>DATE</b> Aug 2022</p> <p><b>DRAWING NUMBER</b> W8_LAN_015</p> <p><b>REV</b></p>

# RESTORATION

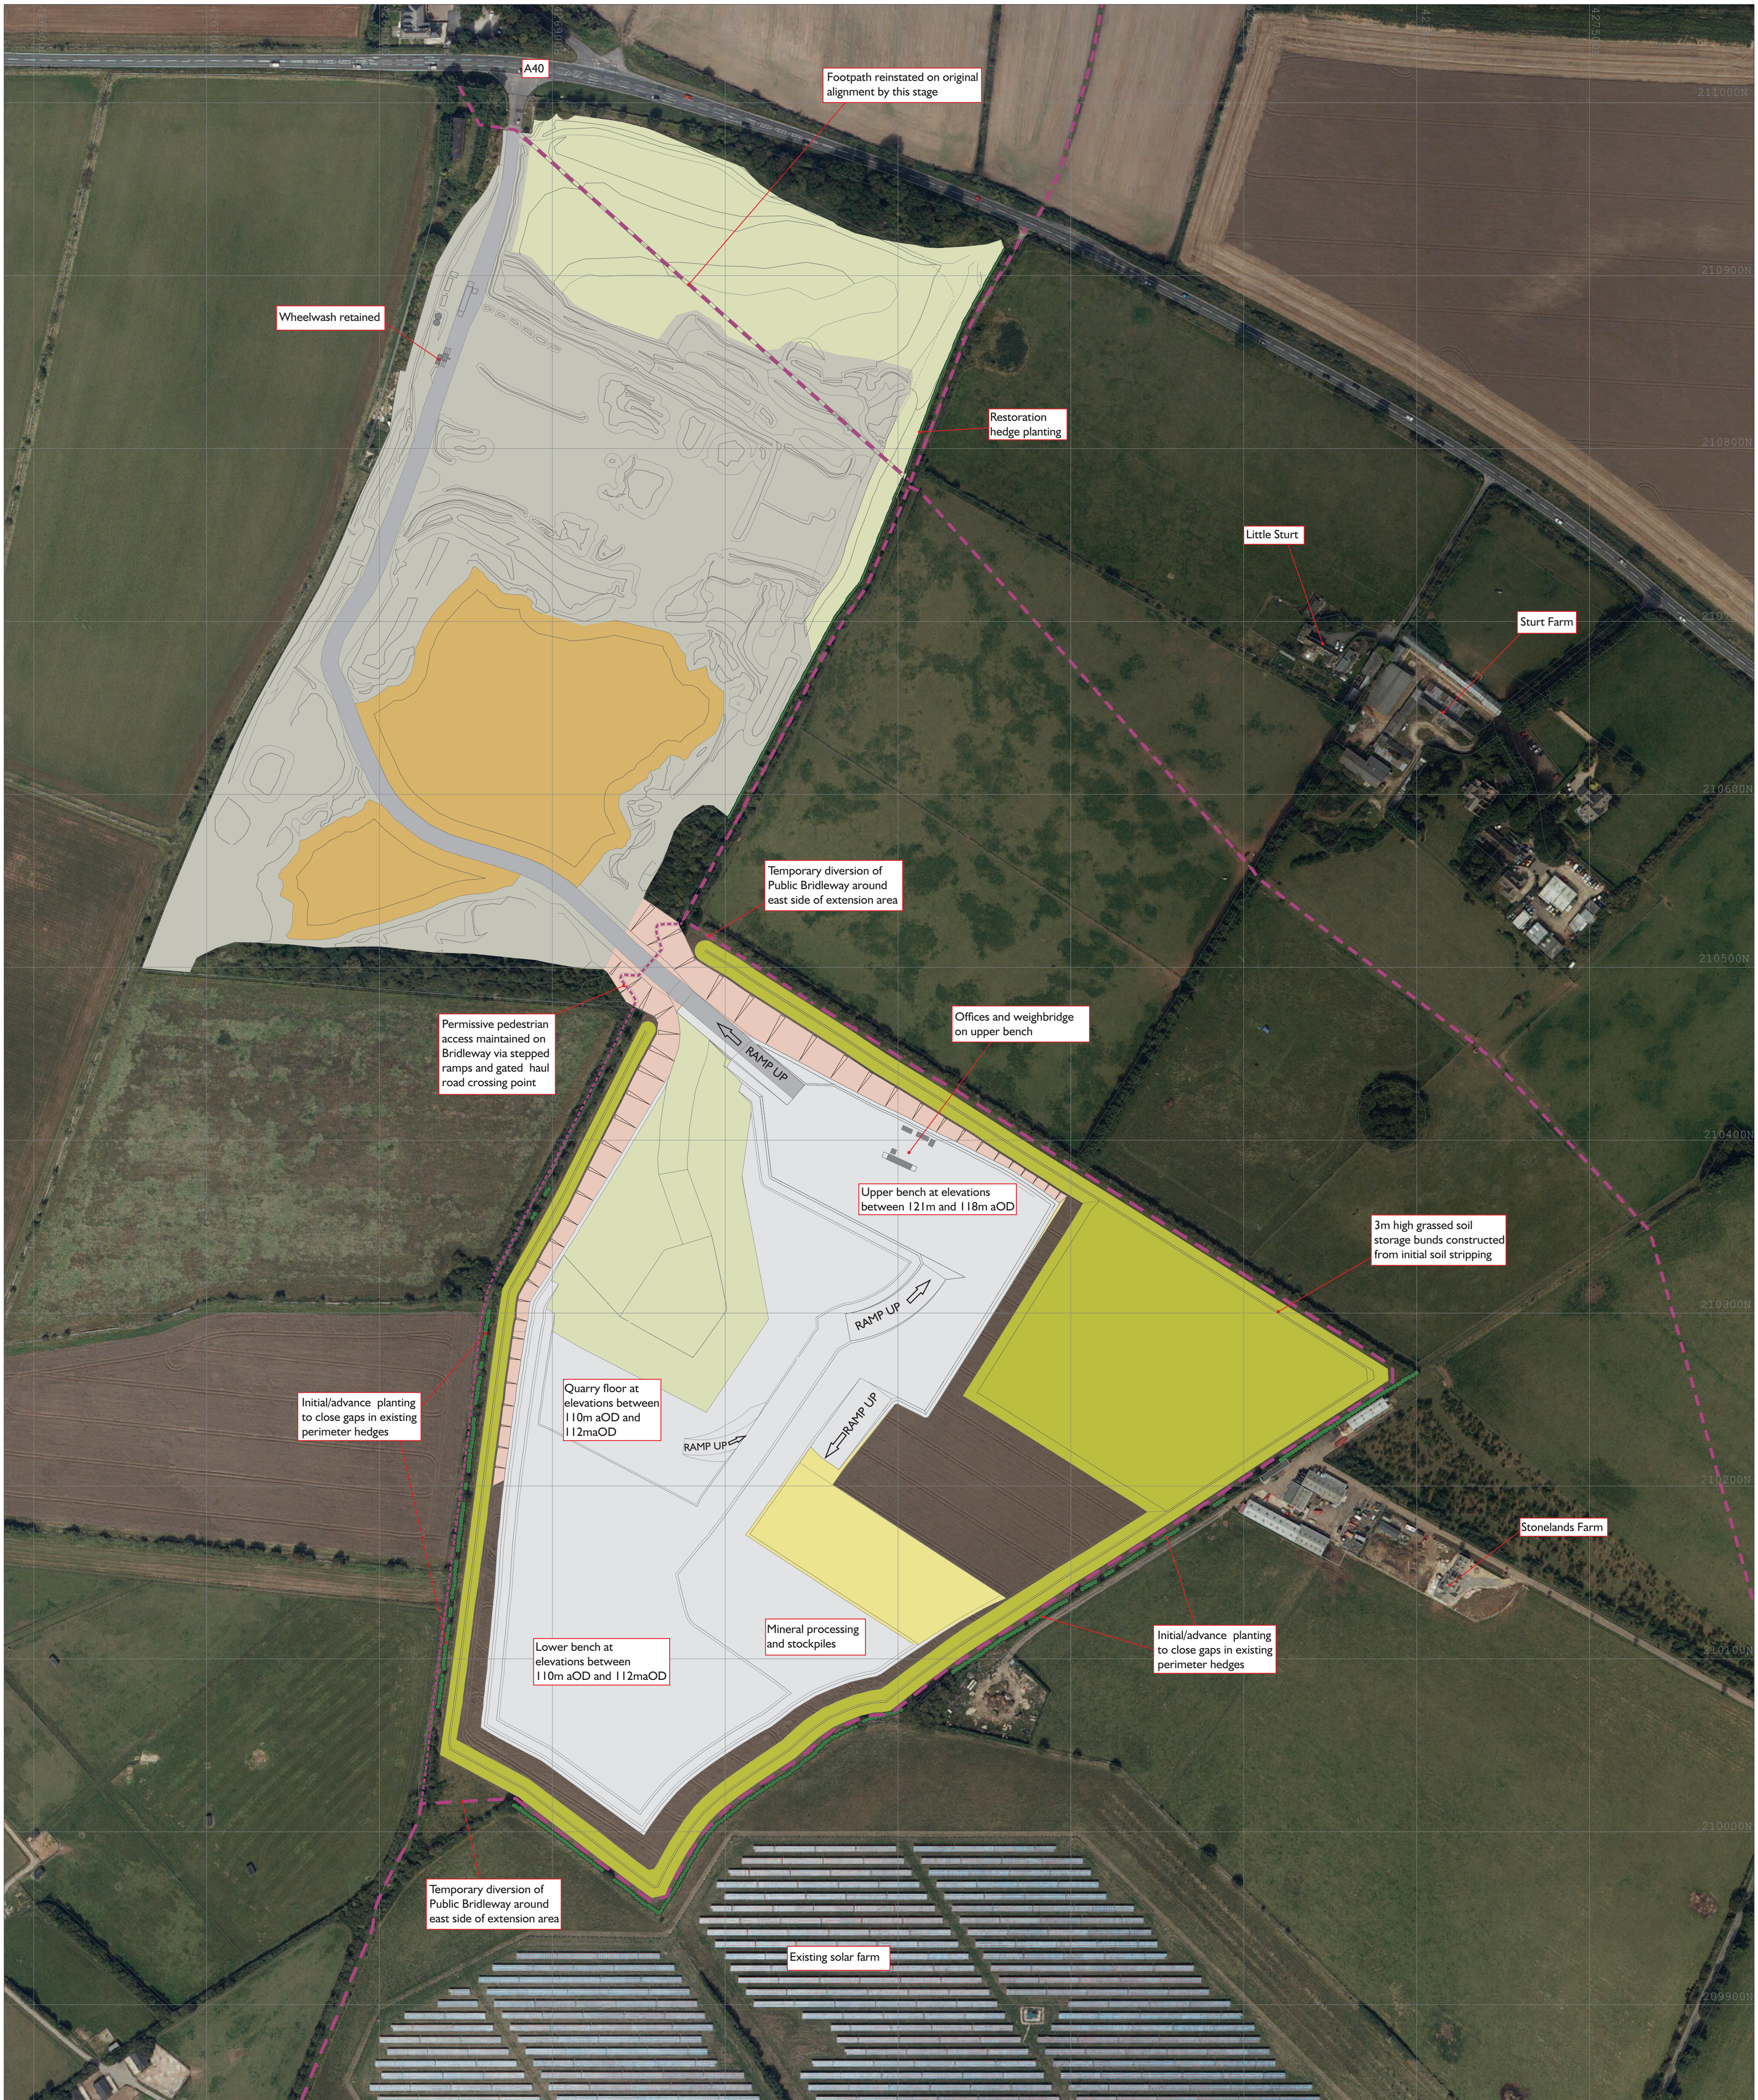
<b>LEGEND</b>		<b>INFORMATION</b>		<b>PROJECT</b>		
	Public Right of Way	  Ordnance Survey © Crown Copyright, 2022. All Rights Reserved. Licence No. 0100031673	 Chartered Surveyors Chartered Landscape Architects Environmental Consultants Health and Safety Consultants		ESP Ltd The Creative Industries Centre Glacier Drive Wetherington WV10 9TG Tel: 01902 771311	
	Permissive footpath open during quarry extension operational period		<b>Whitehill Quarry, Burford Proposed extension</b>			
	Quarry haul road	<b>CLIENT</b>		<b>Development Stage B - End Working Phase 4</b>		
	Active existing quarry area (as of Spring 2022)			<b>SCALE</b> I: 1250 @ A0 I: 2500 @ A2	<b>DRAWN BY</b> KH	<b>DATE</b> Aug 2022
	Area of existing quarry and extension area partially restored (existing quarry as of Spring 2022)			<b>DRAWING NUMBER</b> W8_LAN_016	<b>REV</b>	
	Grassed soil storage mound (restoration material)					
	Overburden and processing waste storage mound (restoration material)

Overburden cut slope within quarry extension area					
	Area stripped of soil and overburden prior to mineral extraction in extension area					
	Extension area quarry bench and face

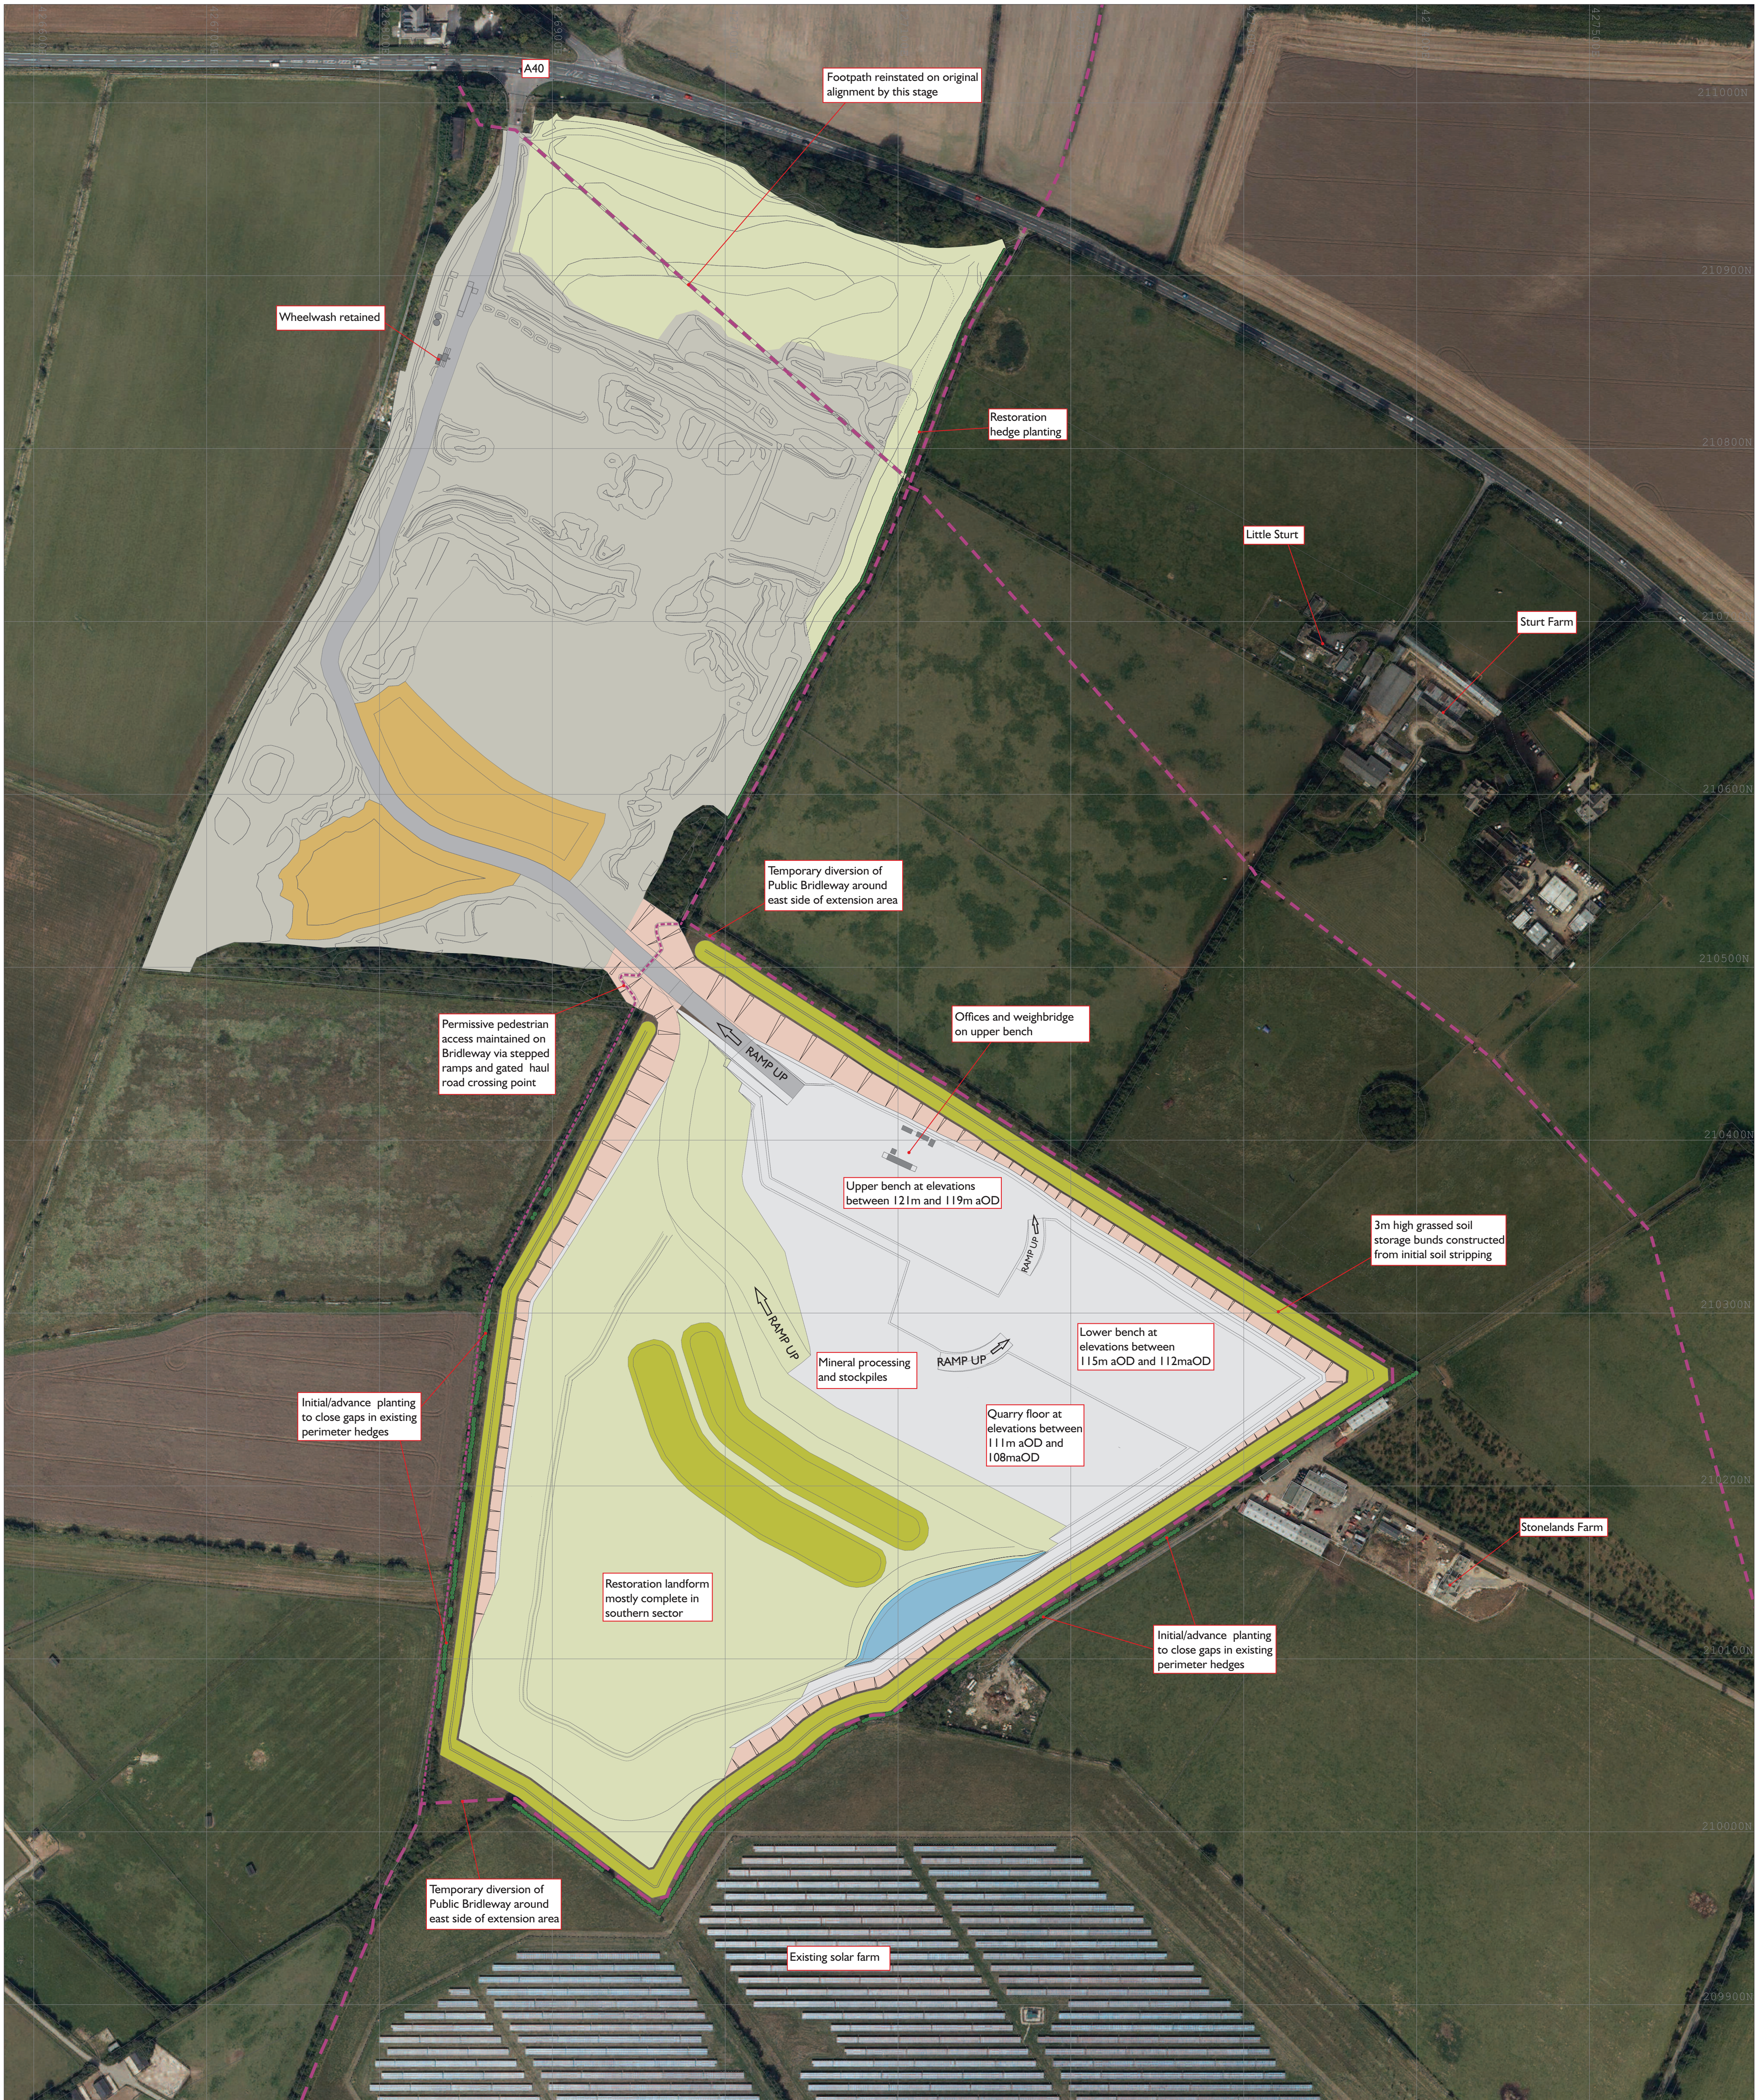
LEGEND		INFORMATION		CLIENT	
	Public Right of Way		North		0 to 100 metres
	Permissive footpath open during quarry extension operational period		0 to 100 metres	Ordnance Survey © Crown Copyright, 2022. All Rights Reserved. Licence No. 0100031673	
	Quarry haul road				
	Active existing quarry area (as of Spring 2022)	<p><b>PROJECT</b> Whitehill Quarry, Burford Proposed extension</p> <p><b>TITLE</b> Development Stage C - End Working Phase 6</p> <p><b>SCALE</b> I: 1250 @ A0 I: 2500 @ A2</p> <p><b>DRAWN BY</b> KH</p> <p><b>DATE</b> Aug 2022</p> <p><b>DRAWING NUMBER</b> W8_LAN_016</p> <p><b>REV</b></p>			
	Area of existing quarry and extension area partially restored (existing quarry as of Spring 2022)		Grassed soil storage mound (restoration material)		Overburden and processing waste storage mound (restoration material)
	Restoration landform mostly complete in southern sector		Overburden cut slope within quarry extension area		Extension area quarry bench and face

Operational sump pond later to form restoration pond		Operational sump pond later to form restoration pond

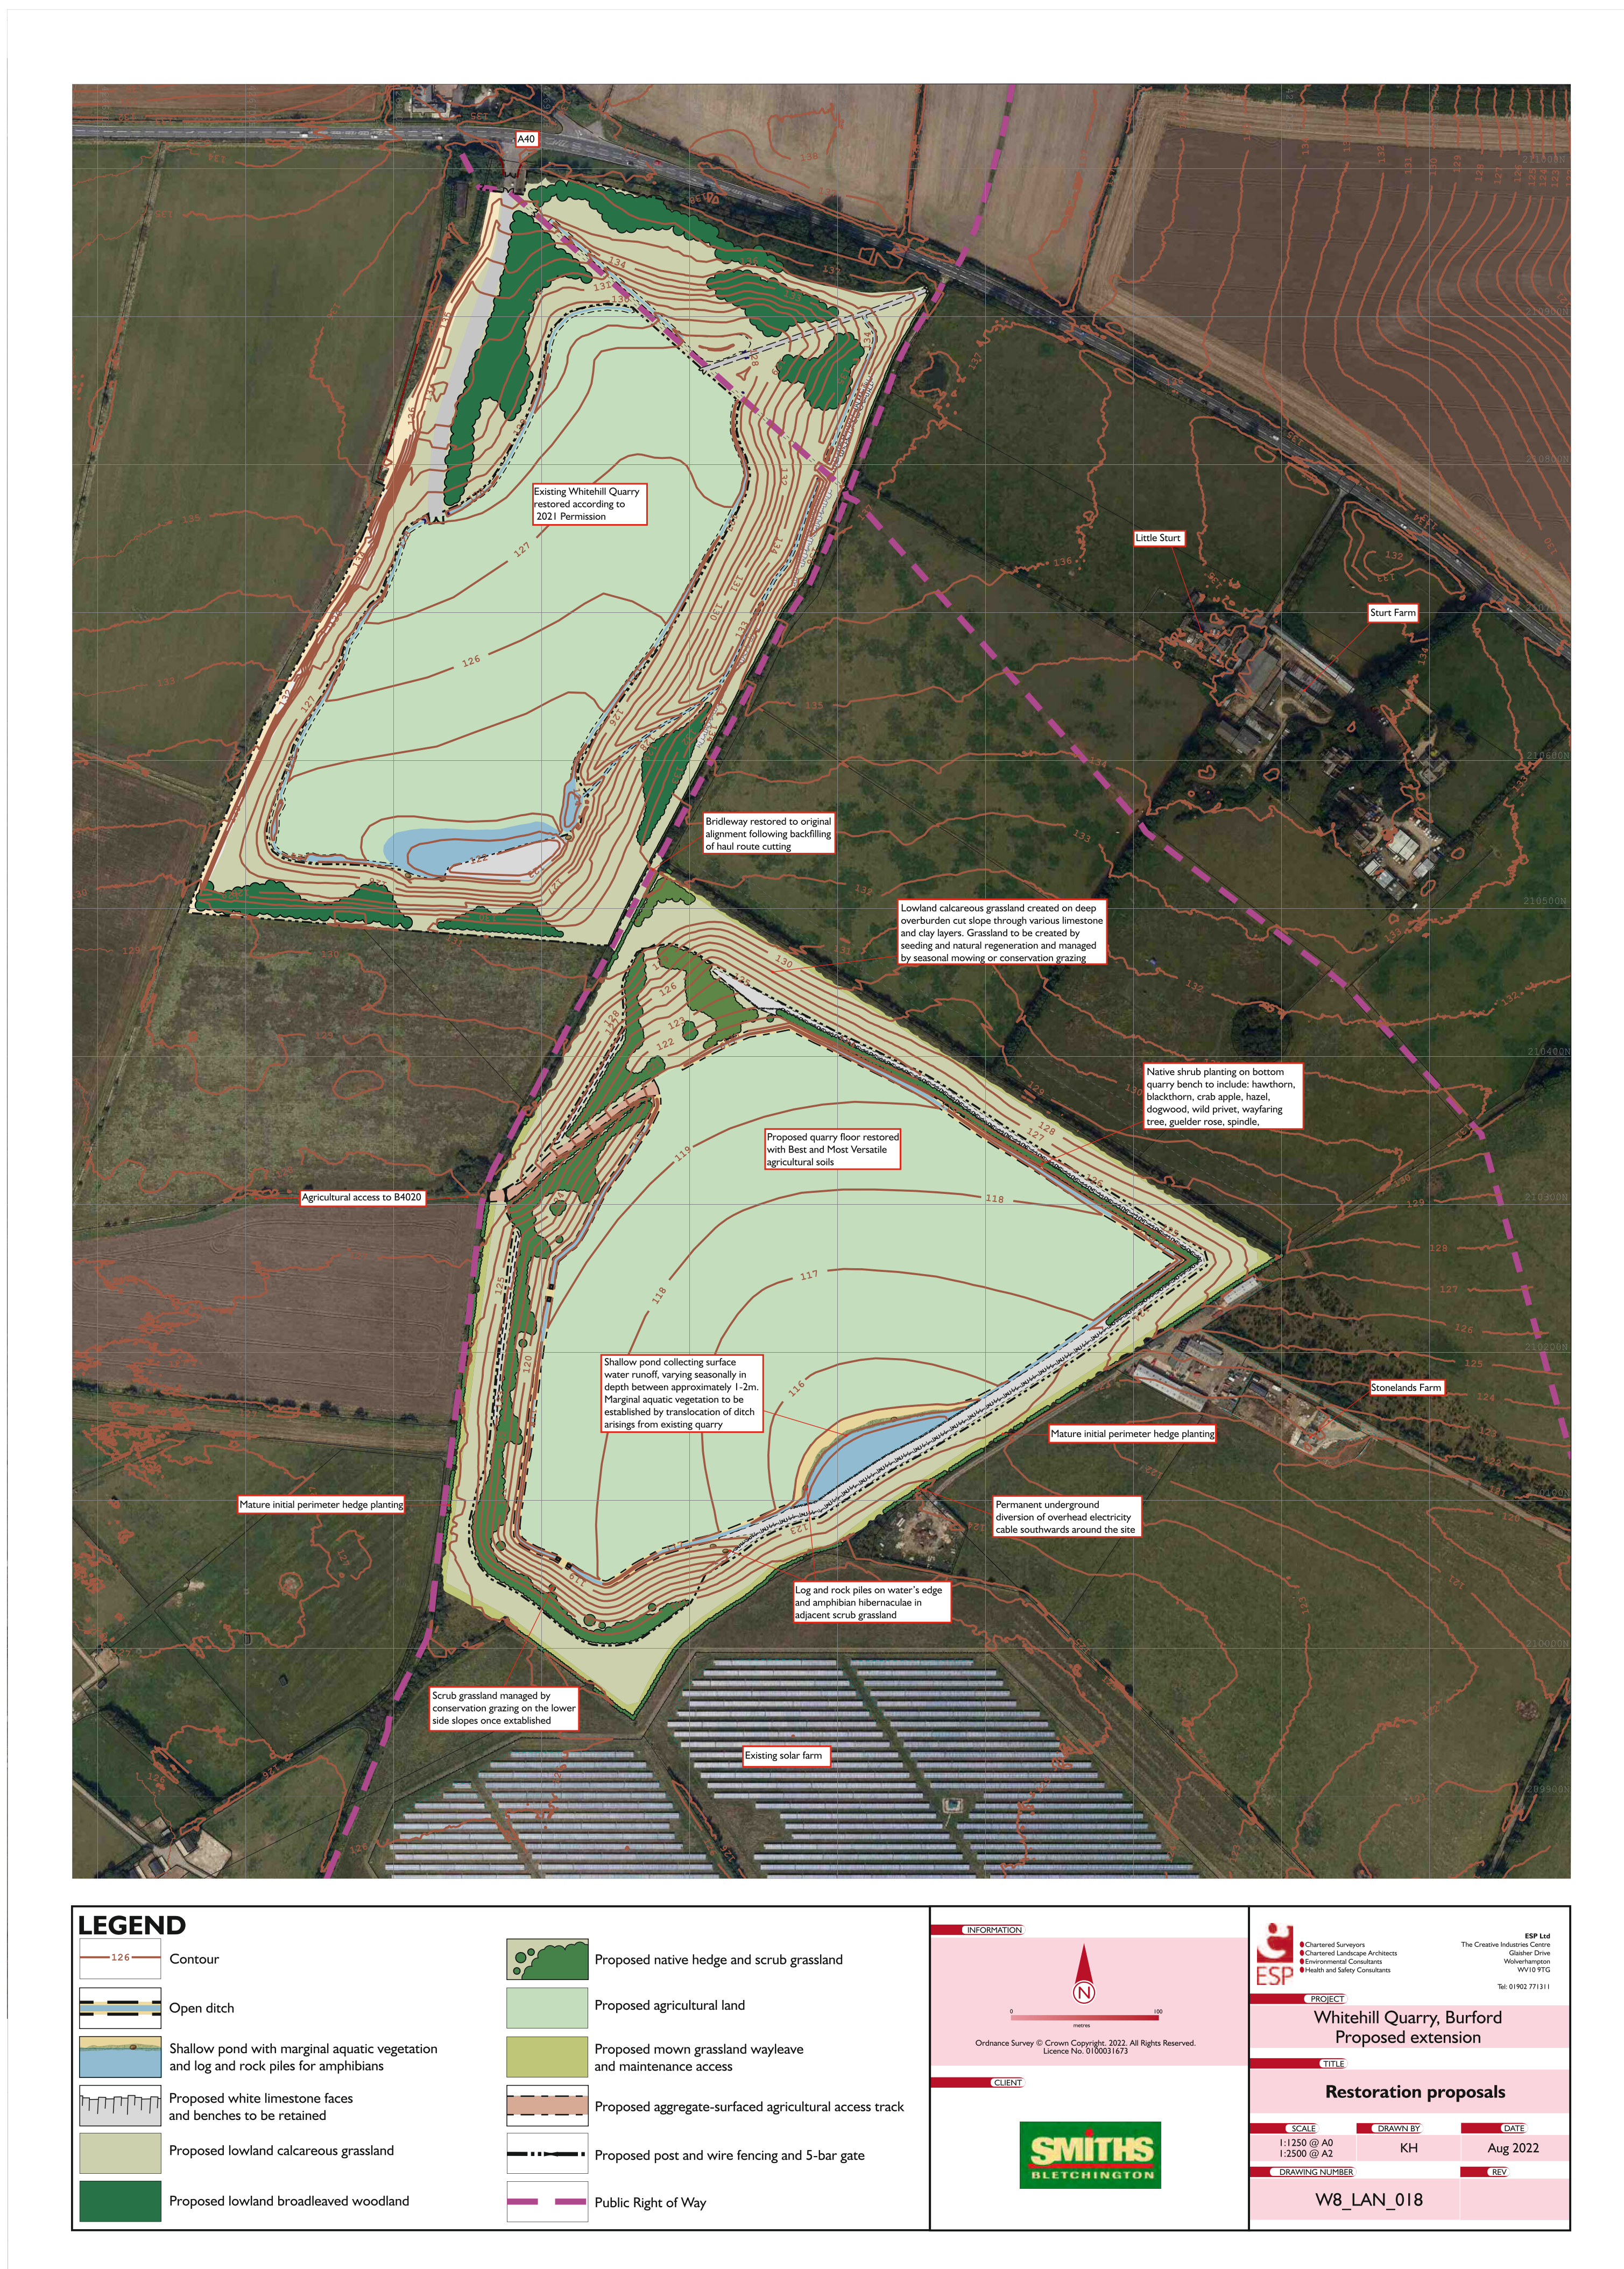
At the end of the day the extension area will be restored at a lower level to agricultural land with the quarry slopes having a mix of limestone grassland, shrubs and woodlands to create some diverse habitats to increase the biodiversity interest of the land. A pond feature will also be created to assist with drainage and again also increase the biodiversity interest of the site.

We try to ensure we restore our quarries as soon as practically possible and once there is sufficient operational space restoration will take place progressively in the worked out quarry areas. The existing quarry is being restored with limestone grassland and scattered woodland planting on the quarry slopes and pastureland on the quarry floor. Similar restoration is proposed for the extension area with the importation of inert materials to ensure the quarry floor is raised above the seasonal water table level.
